Foxboro

T940(X) to T2750 Migration Guide

HA032026

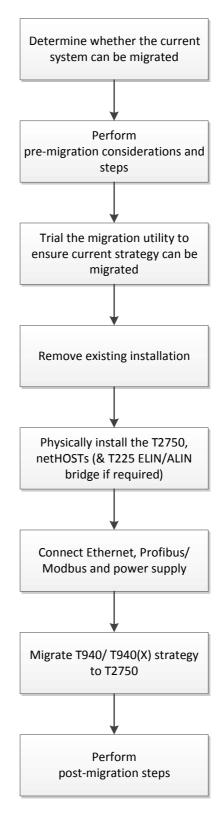
The following flowchart shows the main steps required for migration from the T940(X) to the T2750.

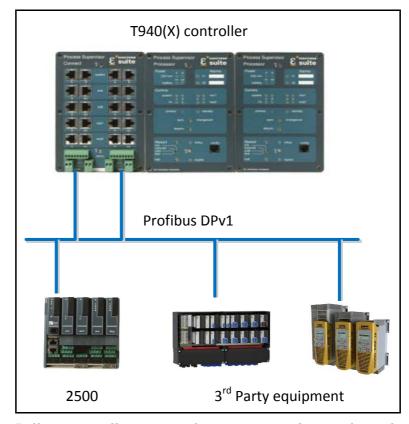
A example installation suitable for migration consists of a T940(X) connected directly to a 2500 and/or other third party equipment, perhaps communicating over a standard Profibus DPv1 network as shown in the following figure.

Different installations may have a varying degree of complexity, with or without Profibus requirements, or perhaps using Modbus. Typically, the system is controlled by one or more T940(X) process controllers, and have one or more items of equipment connected to the controller - often over Profibus or Modbus - but sometimes with other protocols. In the example installation above, the T940(X) communicates using the Profibus protocol via its internal Profibus gateway cards.

Note: The T940(X) uses RJ45 connectors to connect to the Profibus network.

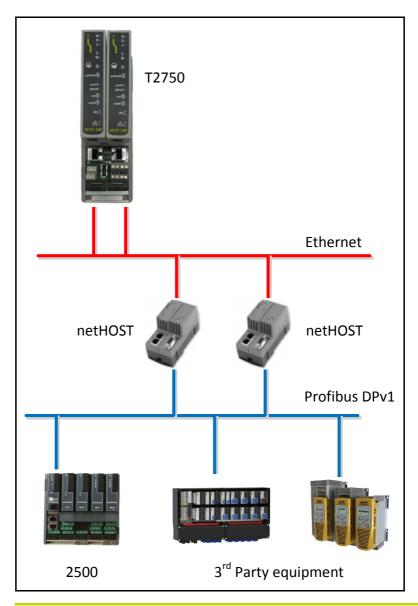
The same installation can be migrated to a T2750–controlled system as shown in the following figure. The T940(X) is replaced by the small T2750 zero I/O base controllers (shown in a dual, redundant configuration) and optional Profibus support is provided by means of two netHOST gateways that are external to the T2750. The principle of operation remains the same except that the Profibus gateways are external and connected to the instrument via Ethernet.

Note: The T2750/netHOST combination uses standard 9-pin D-connectors to connect to the Profibus network.

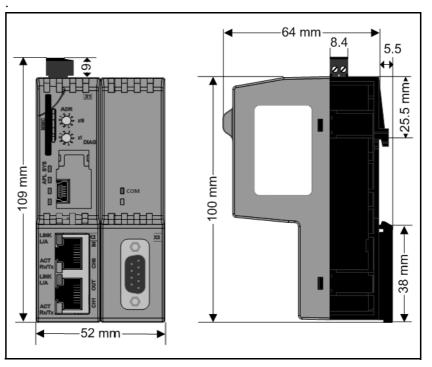
The following figure shows the dimensions of a netHOST

The netHOSTs are typically mounted beside the T2750, and the total width of a T2750 and two netHOSTs fit comfortably within the gap created by the removal of a T940(X). However, it is not necessary to mount the netHOST in close proximity to the T2750, as communication between the two devices is performed using standard 100Mbps Ethernet.

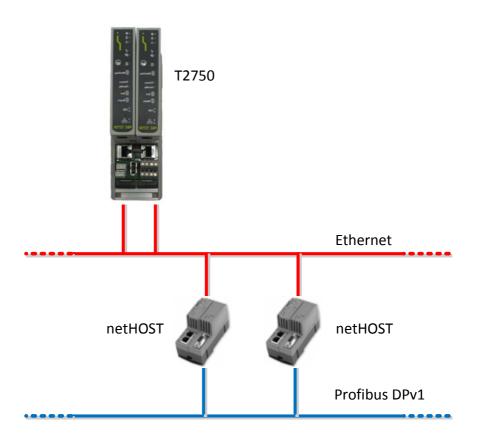
The netHOST communicates with the T2750 using standard 100Mbps Ethernet through either one of the RJ45 connectors of the integrated two-port switch. Typically, the output of netHOST would feed a network switch or hub before being routed to the T2750 (though technically – but not advised – the output of the netHOST could be connected directly to the T2750). Consideration to redundancy on the Ethernet network should be given when designing the Ethernet system.

The above figure shows a typical Ethernet network connecting each netHOST to it's corresponding T2750 processor card. A total of four network feeds would be required for this setup.

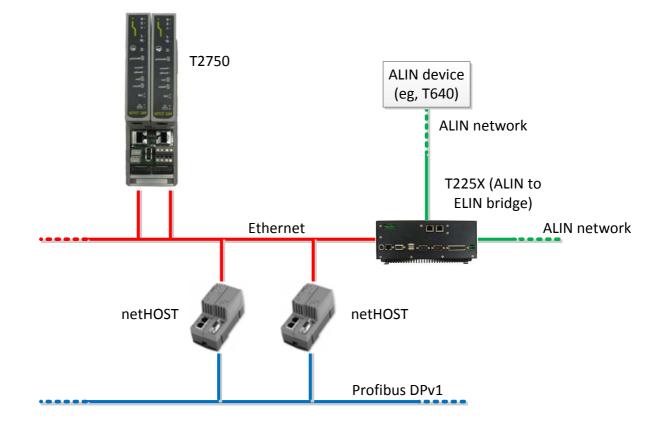
If the number of Ethernet feeds is severely limited, the netHOST's 2-port switch can be used to distribute a single feed to the netHOST and a single T2750 processor card.

Important: Using the netHost's built-in 2-port switch to distribute an incoming Ethernet feed introduces a single-point-of-failure and is therefore not recommended practice.

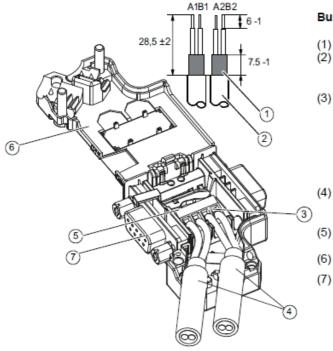
Bus cable installation

- Cable shield
 -) Bus cable (e.g. 6XV1 830-0EH10) - strip insulation, e.g. with stripping tool 6GK1905-6AA00
- Screw-type terminal block on connector p.c.b. for connecting the bus cable Insert the green and red cores in the screw terminal block (A1, B1 or A2, B2; Recommendation: A = green, B = red)
- Press the cable sheath between the two cable clips. The cable shield must lie bare on the contact.
- Screw the green and red cores tightly in the screw terminal.
- Close the housing cover and screw it shut.
- PG socket (only with 6ES7972-0BB42-0XA0)

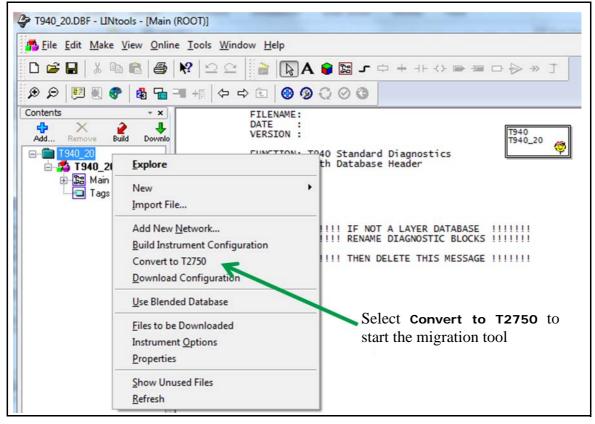
3 Right-click on the instrument, and select **Convert to T2750** (see figure below).

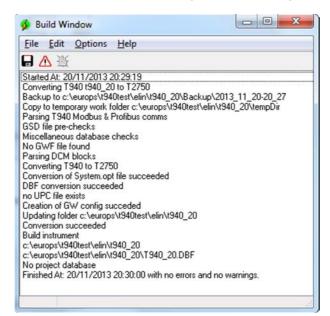
7 Examine the contents of the Build Window to check for any warnings or errors that occurred during the migration (refer to "Migration errors" on page 27 if necessary for additional information on the meaning of the warnings and errors).

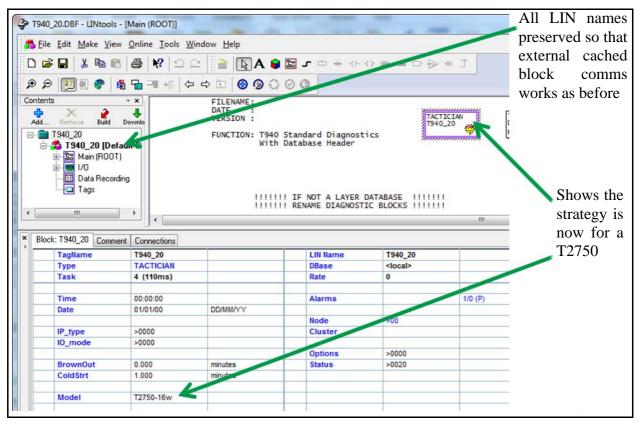
8 If the migration completed successfully, the current loaded database shown in LINTools is the new T2750 version, with a correct Tactician header block (rather than the T940 header block) and appropriate DCM blocks.
